Notice to Water Utility Customers

Water Service Line Materials

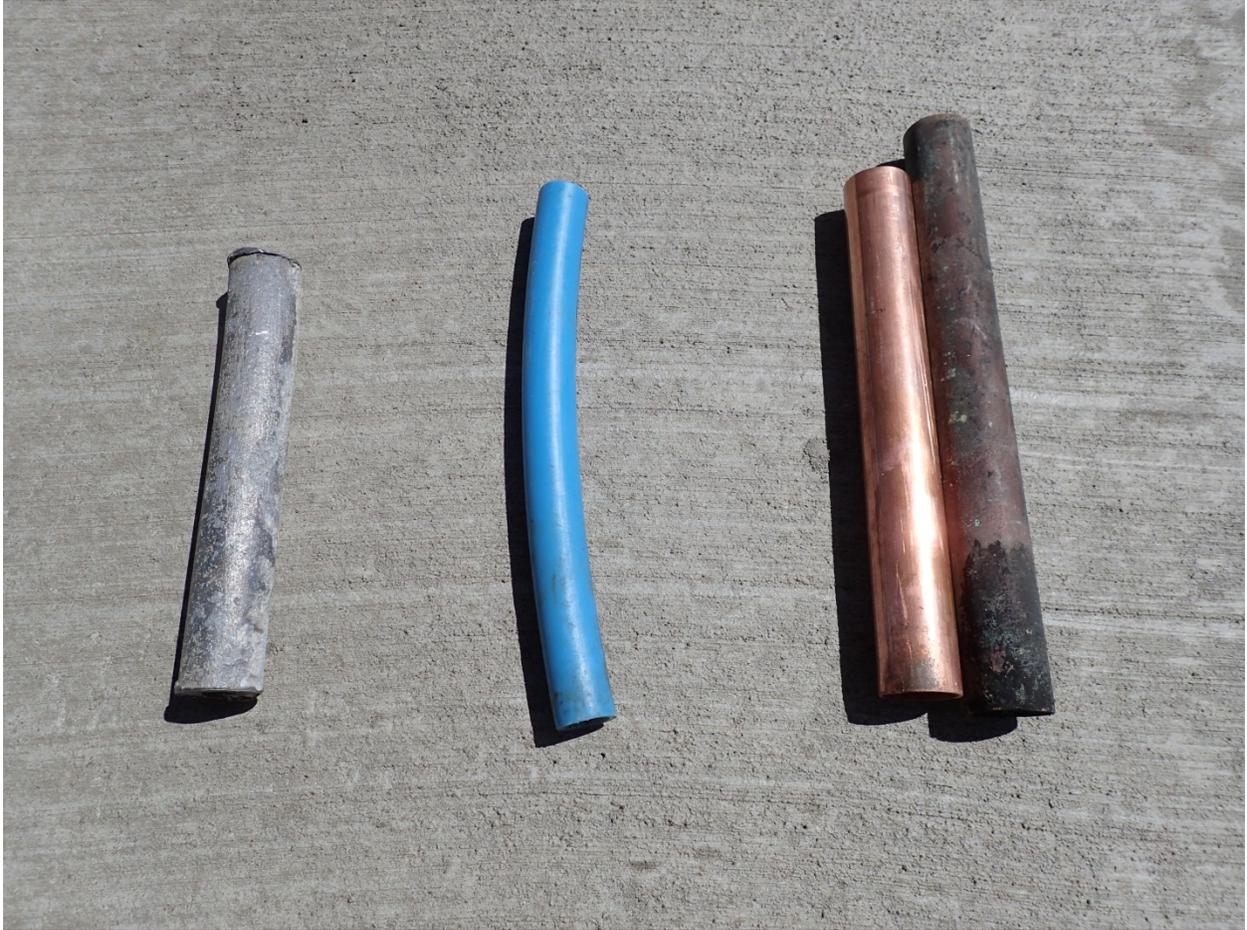
The photo below contains service lines of different materials as an aid to help people identify service line materials that may be in use. Service lines materials typically can be verified in the vicinity of the water meter or at locations where the line enters the structure, crawlspace, or meter pit. The dull gray metal colored service line is made of lead and is positioned at the left in the photo. The blue plastic line is made of polypropylene and is positioned in the center of the photo. The lines positioned at the right in the photo are copper (new and tarnished).

Left to right: Lead service line, polypropylene service line, copper service lines (new and tarnished).

The City requests that you examine the location where the service line enters your structure, or examine the materials of construction near your water meter. If you observe a lead service line or a service line constructed of materials not shown above, we request that you call the Utility Department at 970-665-6558 and identify your address. A lead service line can be confirmed if it scratches easily with a key.
